Investigation of the internal structure of a brick chimney

Description of problem

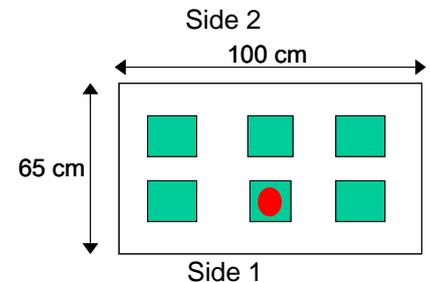
The chimney is constructed of bricks and contains six different pipes at the top of the chimney. Not all these pipes are however going from bottom to top of the chimney. Instead they start at different levels within the building. A simple sketch of the chimney top is given at right. The red mark shows the location of an aluminium pipe within one of the chimney pipes.

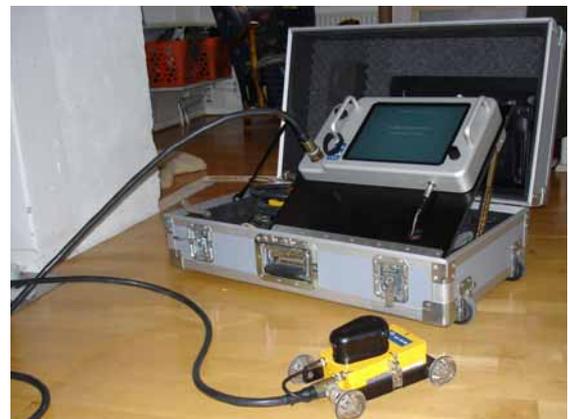
The measurements made in this application note were all carried out with Malå GeoScience CX system with the 1.6 GHz antenna.

The results of the measurements were analyzed within the CX Main unit software and JPEG-images were saved for presentation of the results as several timeslices from the different investigated spots of the chimney. Velocity analyzes, in terms of hyperbola fitting, were carried out in RadExplorer.

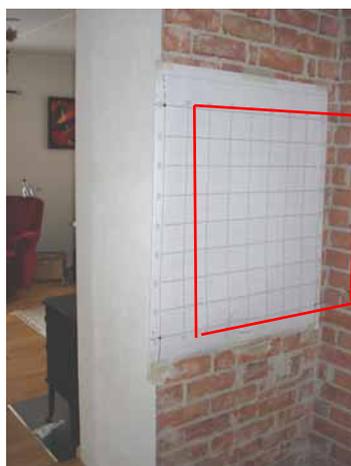
Side 1

The picture at left below is referred to as side 1, while the other side of the chimney (with the corresponding position of the measuring area marked with red) is referred to as side 2. As seen, a stove is installed at this side, which gives one indication of a pipe location. The red areas show the position of the made Grid measurements.

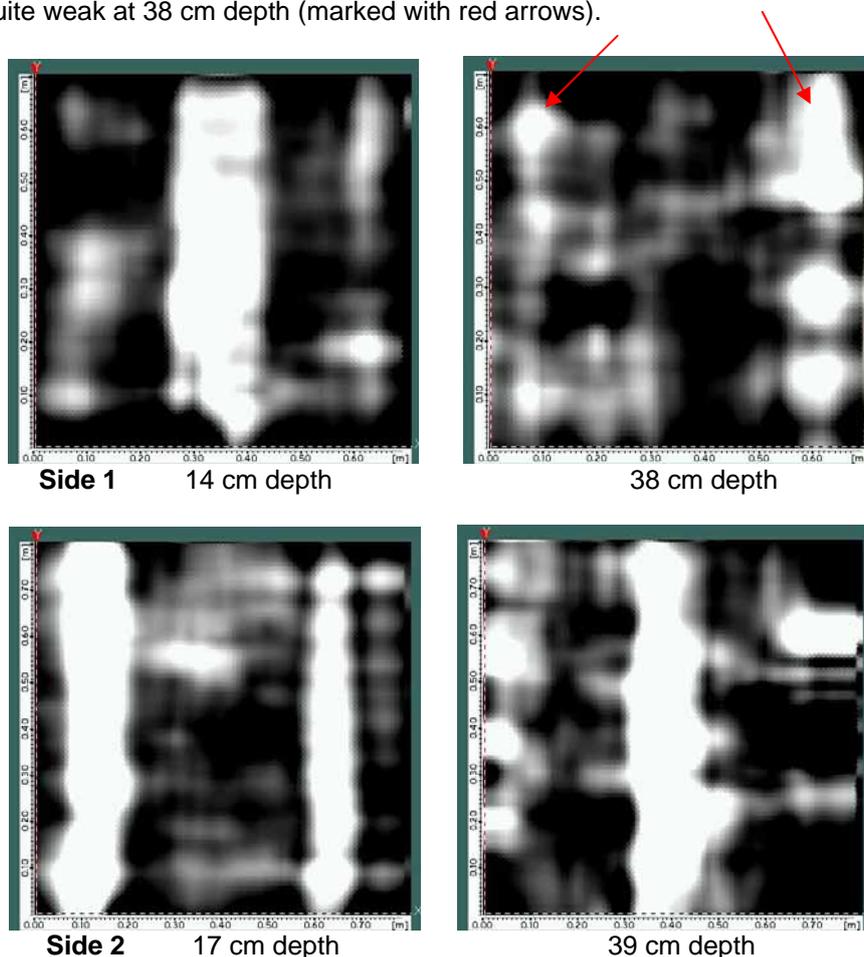
The two GridProjects made on the 1st floor clearly show the location of the chimney's internal pipes closest to the measured side. Indications of the second pipe layer is also seen from both sides. At side 1 the indications are quite weak at 38 cm depth (marked with red arrows).

At side 2 the reflections of the pipe closest to side 1 is as strong as measured from side 1 indicating a difference in material. This pipe, as seen above, contains the aluminium pipe with a diameter of approximately 5 cm.

From the two Grid measurements from side 1 and 2 on the 1st floor it can be concluded that the pipes are located as follows:

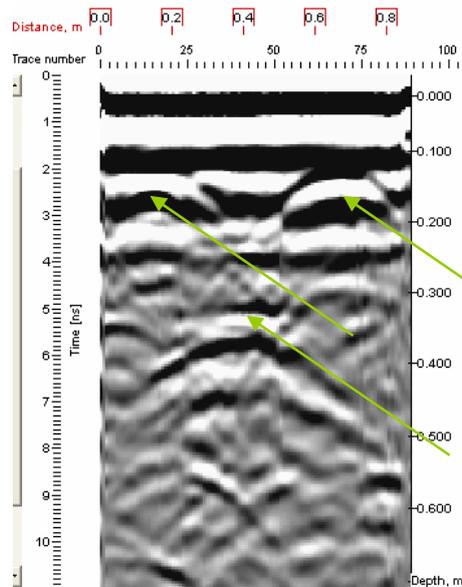
The radargram below is measured on side 2 from 0 to 80 cm (left to right). Also here the three identified pipes in the GridProject results above are seen very clearly, as quite wide hyperbolas, marked in the radargram with arrows.

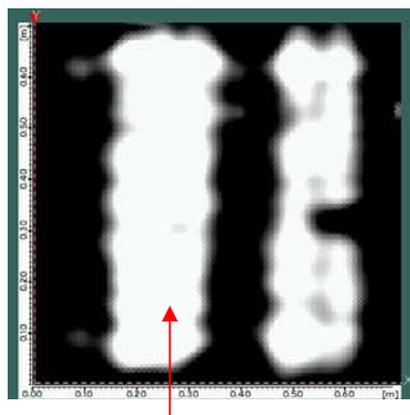
2nd floor 16 cm depth

On the 2nd floor only one side of the chimney was free to measure, this side corresponds to side 1 on the 1st floor.

Here two pipes were clearly identified at a depth of approximately 16 cm. One of these corresponds to the pipe from the first floor (the left one is on the same location as the pipe with the internal aluminum pipe, marked with an arrow) but also another is seen, a ventilation pipe starting between the two floors. Again the pipe containing the aluminum gives a bit stronger back-reflection. The two pipes are also seen in the single measured radargram as clear hyperbolas, marked with arrows in the picture above. However, the second layer is harder to identify, most probably due to the fact that the two pipe layers are situated on top of each other, giving reflections interacting. Unfortunately the GridProject could not be started at the edge of the chimney, so that's why the pipe from the stove is not seen at all.

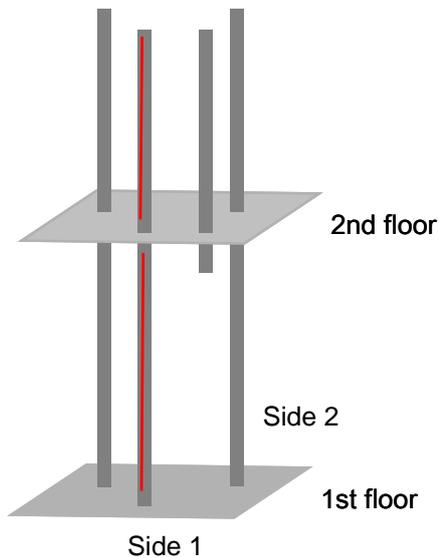
A simple drawing of the pipe location at 1st and 2nd floor is given at left. As seen the pipes on side 2 goes through both floors, while one of the pipe on side 1 only goes through the second floor. The chimney contains 6 pipes in total, so the two missing pipes in the picture at left are only going from top of the 2nd floor and up.

The pipe (on side 1) containing the aluminum pipe is marked with red.
